March 1976

NATIONAL AEROSPACE LABORATORY NLR

NLR TR 76035 U

SCANNING ELECTRON MICROSCOPY OF FRACTURE SURFACES OF CARBON COMPOSITE MATERIALS

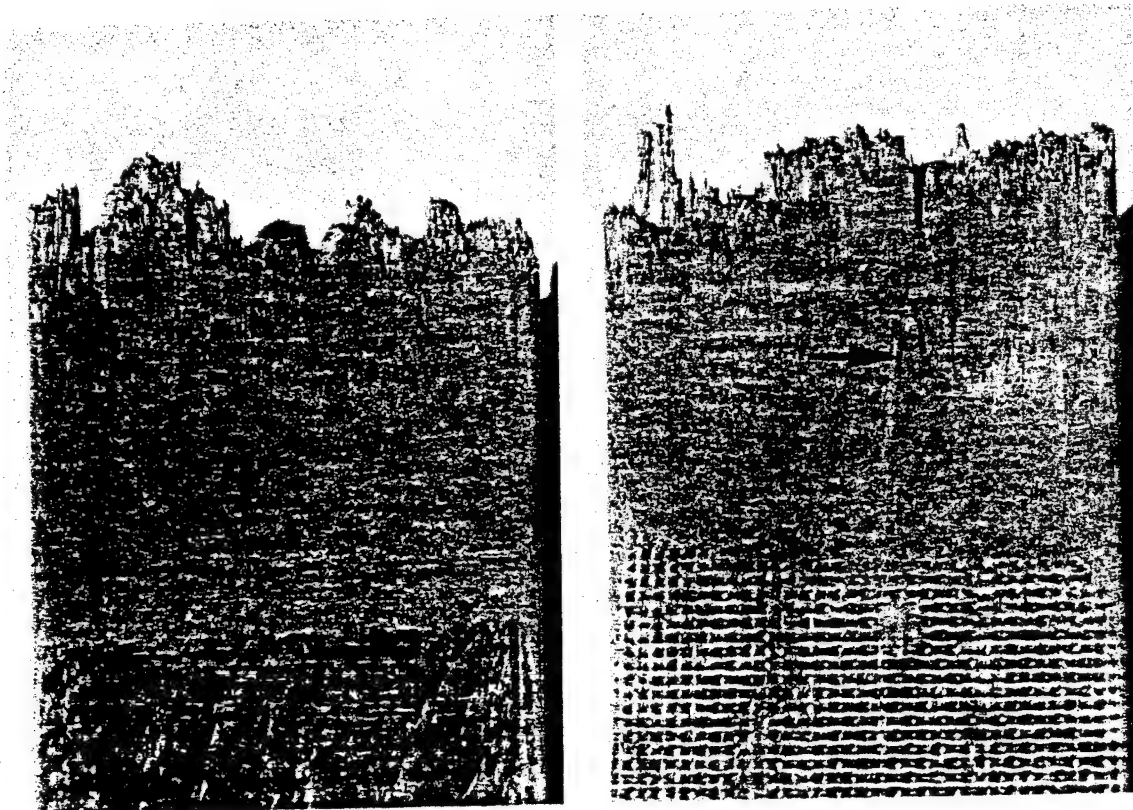
Low magnification photographs of a tensile fracture are shown in figure 6. The specimen was "waisted" in the thickness direction in order to prevent failure in the grips. Failure occurred in the thinnest section. In one part of the specimen delamination occurred, indicating that the waisting procedure introduced stress concentrations leading to shear stresses exceeding the interlaminar shear strength. Figure 6 shows a rather straight fracture surface, indicating a good interface strength (although a straight fracture surface is also partly caused by the waisting procedure).

Figure 6 Fracture surfaces of a "waisted" tensile specimen

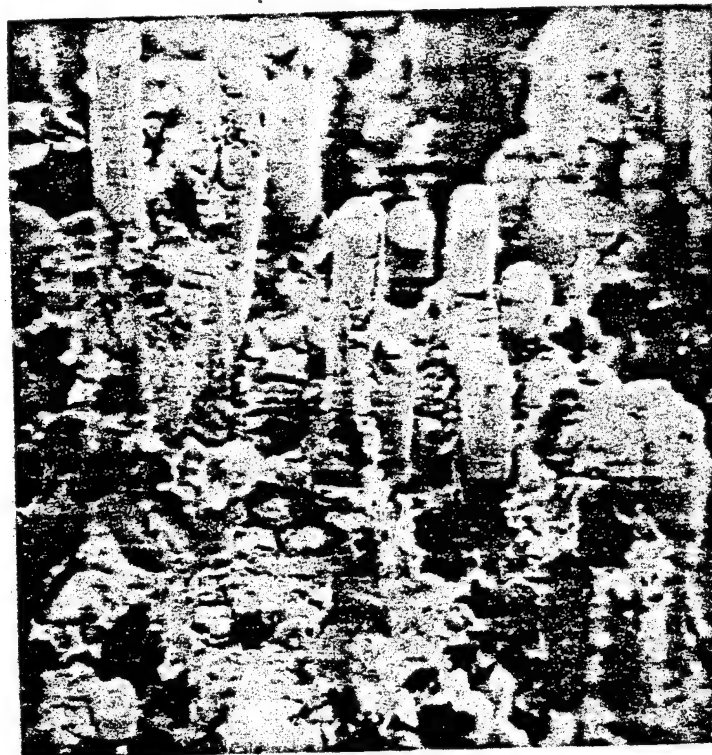
Figure 7 presents an SEM photograph of the fracture. There is only

slight fibre pull-out. Clusters of fibres have been broken with resin adhering to the fibres. This indicates that there is a strong interface since clusters of fibres then react as integral units and fracture will initiate from weak planes rather than from each individual fibre.

Figure 7 SEM photograph of the fracture surface shown in figure 6

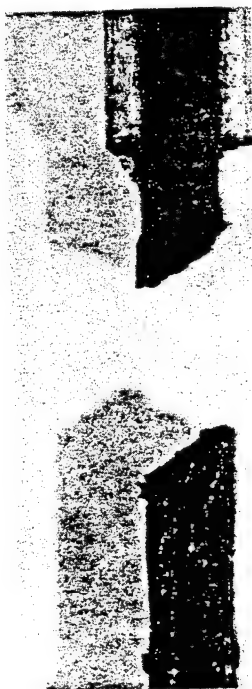
The macroscopic appearance of a compressive fracture of a carbon/epoxy specimen is a relatively smooth fracture surface at an angle of 45 to 60° with the loading direction (Fig. 8 and 9). During the fracture process interlaminar cracks can be formed and local buckling can occur, resulting in an irregular, stepped fracture surface (Fig. 9).

Figure 8 Compressive fracture surfaces of a carbon/epoxy specimen

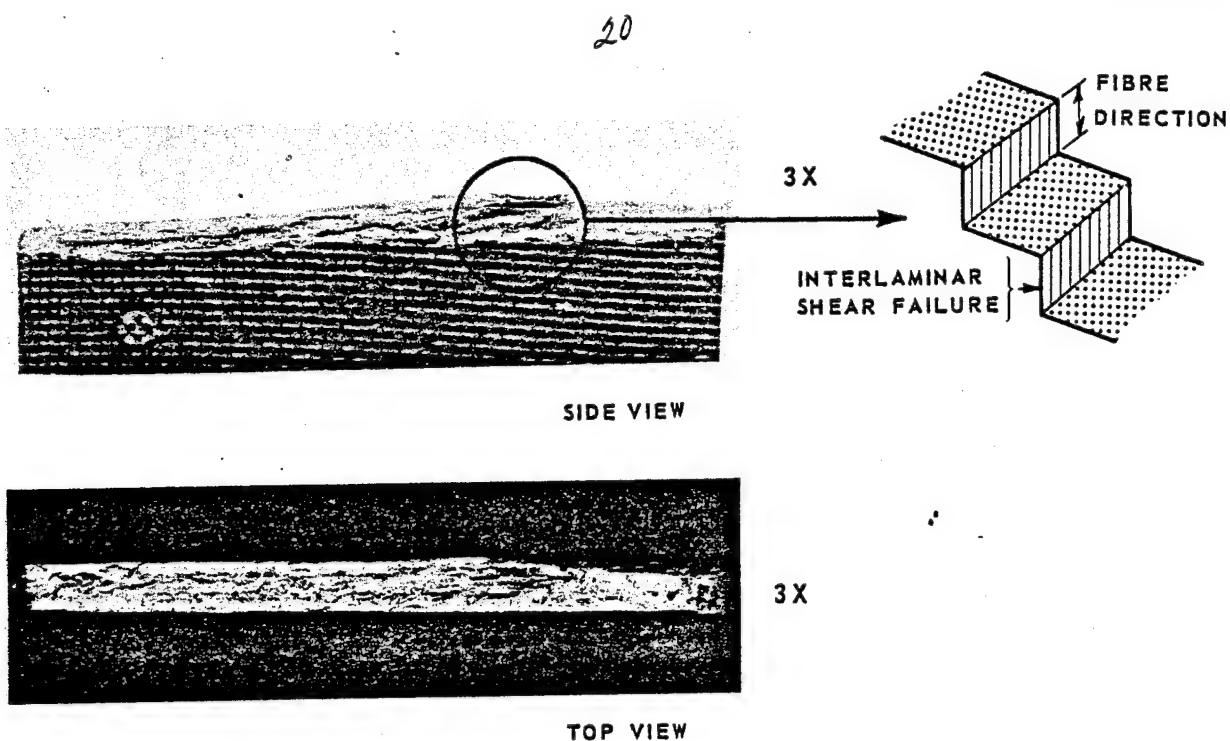
Figure 9 Compressive fracture surfaces of a carbon/epoxy specimen

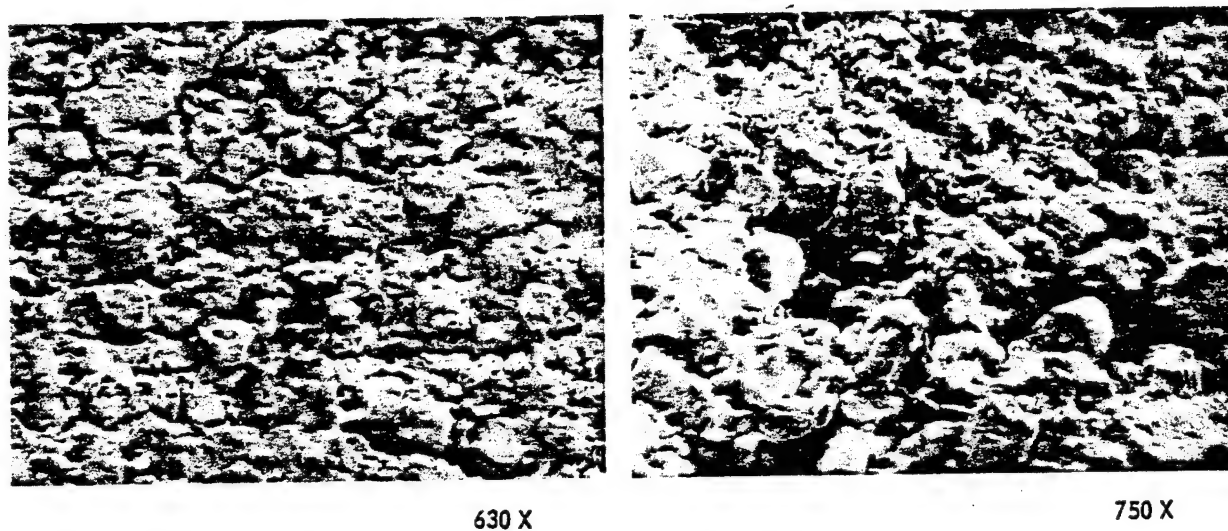
At high magnification it can be observed that fibre parts have been spread over the surface (Fig. 10). Accurate examination of single fibres shows that some failed by microbuckling. The buckling occurred for a number of fibres in the same direction, thereby indicating a general buckling failure for parts of fibres integral with the matrix. The occurrence of buckling will depend on the interface strength. Examination of a large area on the fracture surface was not possible, owing to damage of the fracture surface by the failure process.

Figure 10 SEM photographs of the fracture surface of a carbon/epoxy specimen failed under compressive loading

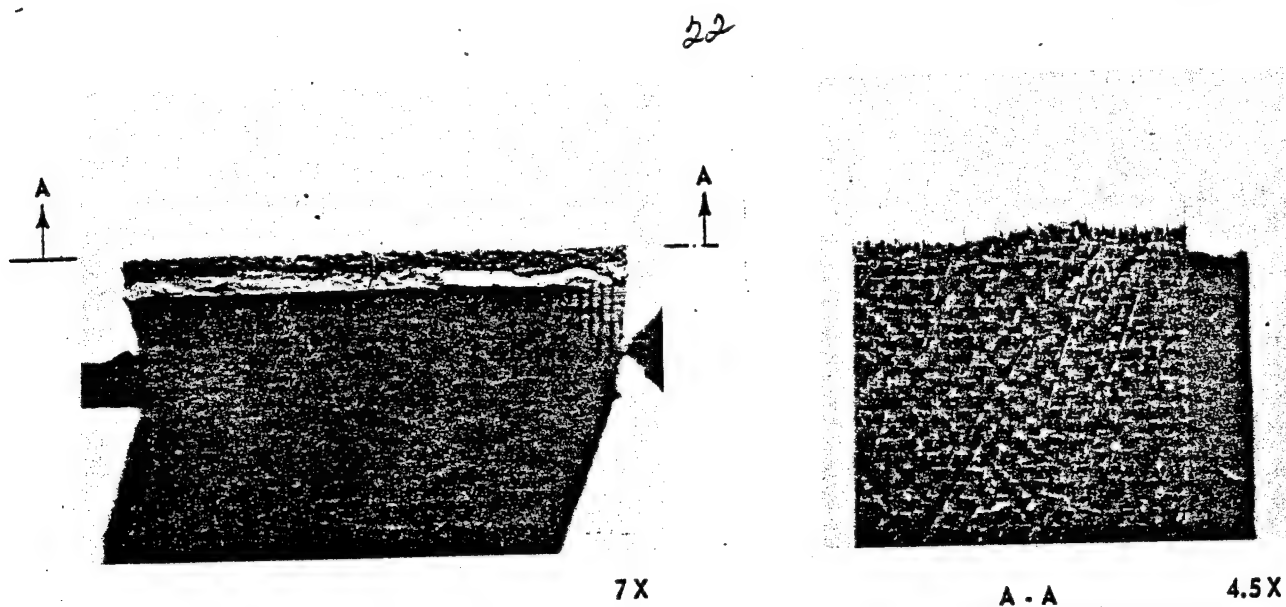
Considering the fracture surface of the investigated specimen at a low magnification, smooth and rough areas are observed (Fig. 12). The smooth area is the result of a compressive failure. The fibrous appearance of the other part indicates fibre pull-out under tensile stresses.

From the low magnification photographs it can be concluded that fracture was the result of flexure rather than shear. However, an SEM

Figure 12 Fracture surface of a three point bend specimen

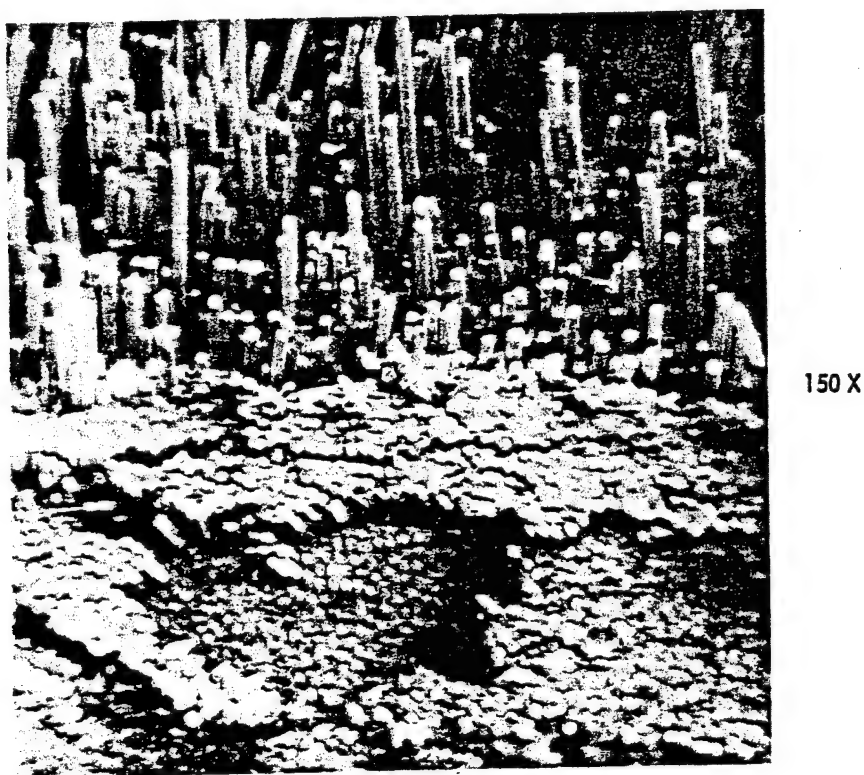
photograph taken from the transition zone also shows interlaminar shear cracks, developed at the neutral plane, figure 13. Away from the neutral plane less shear cracks are observed, figure 14, 15. The flexural failure mode has therefore probably been initiated by shear forces.

The tensile part of this beam specimen shows a considerable fibre pull-out, figure 13. No resin parts adhere to the broken fibres and clusters of fibres have not broken as integral units. Thus, the interface bond was not so good as the interface bond in the tensile specimen discussed previously (compare Fig. 7 and Fig. 13).

Figure 13 SEM photograph of the fracture surface shown in figure 12, at the location of the "neutral plane" (150x)

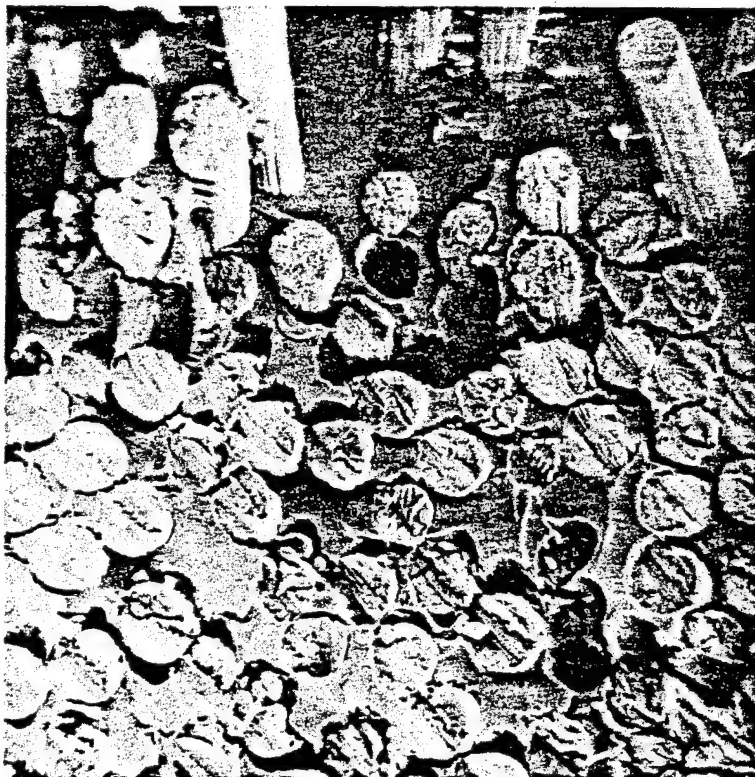
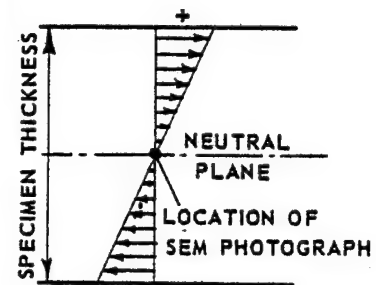
Fig. 14

Figure 14 to 16 show a large number of fibres failed by microbuckling. The actual loading direction can be derived from the buckling orientation, since buckling of all the fibres occurred in the same direction.

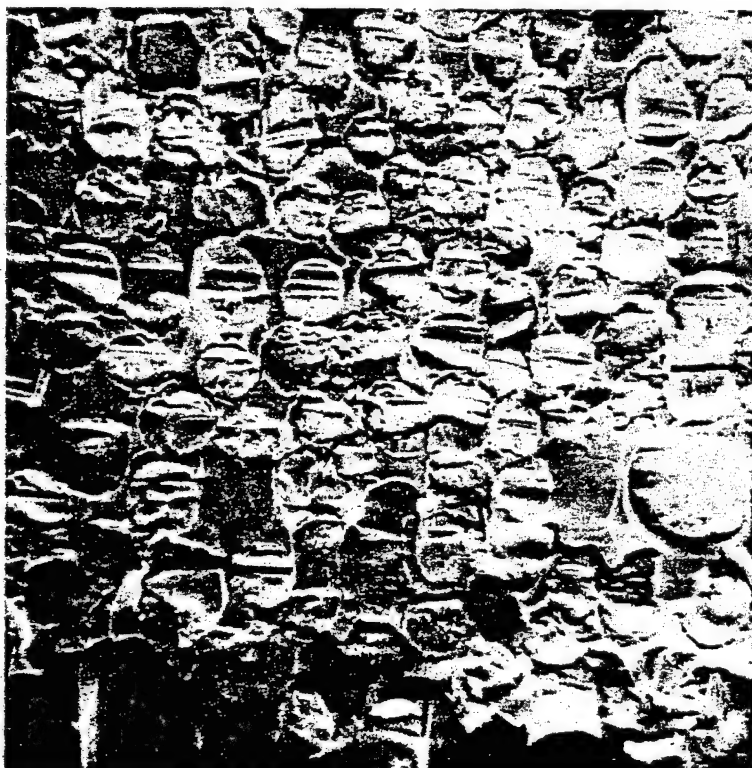
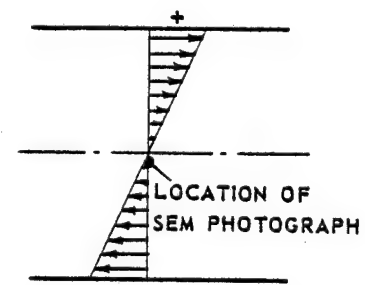
Figure 15 SEM photographs showing interlaminar shear cracks
(upper figure) and fibre buckling

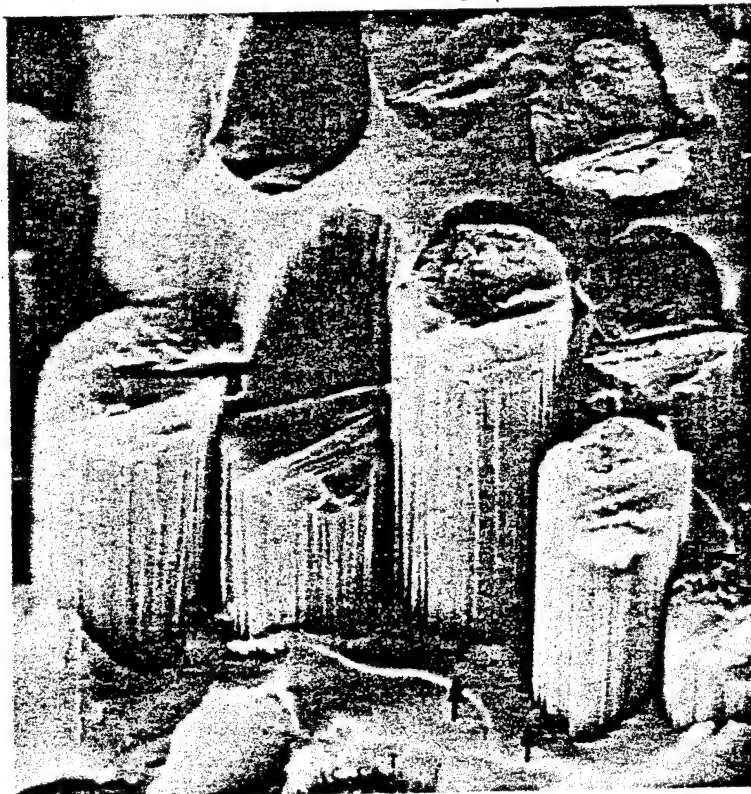
From figure 16 it can be seen that surface wetting of the fibres by the resin was very good. At the bottom of some fibres in figure 16, several matrix cracks have initiated in a radial direction. These cracks probably originated at the circumference of fibres under influence of a combination of residual shrinkage stresses in the matrix and additional stresses due to the fracture process. A theoretical consideration of Chamis (Ref. 9) on residual stresses in polymer matrix composites shows that the resin hoop stress might reach 40 MNm^{-2} , figure 17. The order of magnitude of the tensile strengths of epoxy resins is 50 to 100 MNm^{-2} . The crack orientation is such that no influence on tensile fracture can be expected.

Figure 16 SEM photograph of fibre buckling (2500x)

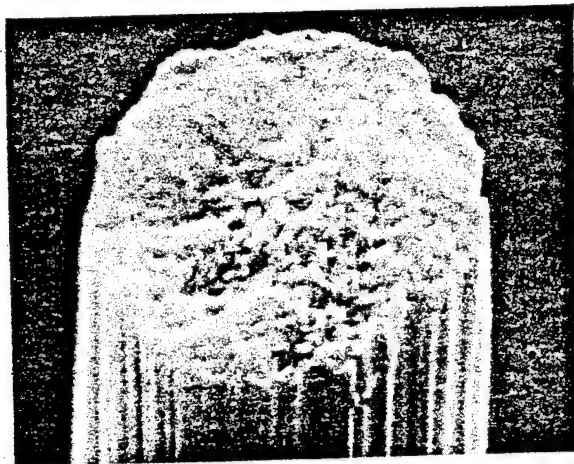
Purely tensile fracture surfaces of single fibres are shown in figures 18 and 19. The fracture surface appearance can be related to the theoretical model of the carbon fibre, reference 14, 15. The precursor of most carbon fibres is polyacrylonitrile. The liquid polymer is pressed through a spinneret having 10,000 microscopic holes, and a silvery white string is obtained. In a stretched condition the strings undergo oxidation and carbonization stages. The initial stretching and the shrinkage during processing helps to increase the axial alignment of the polymer molecules. During processing a ladder struct-

Figure 18 Tensile fracture
surface

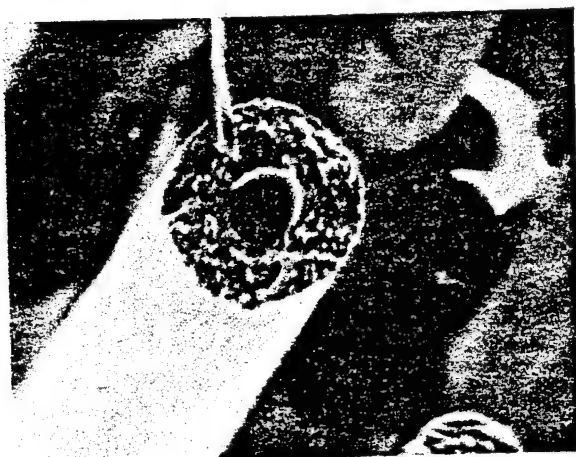
Figure 19 shows a peculiar shape for a carbon fibre, namely a hollow fibre. It is not clear whether this exceptional shape is due to the spinning process or is caused by "internal oxidation" of the PAN fibre.

Figure 19 A hollow carbon
fibre

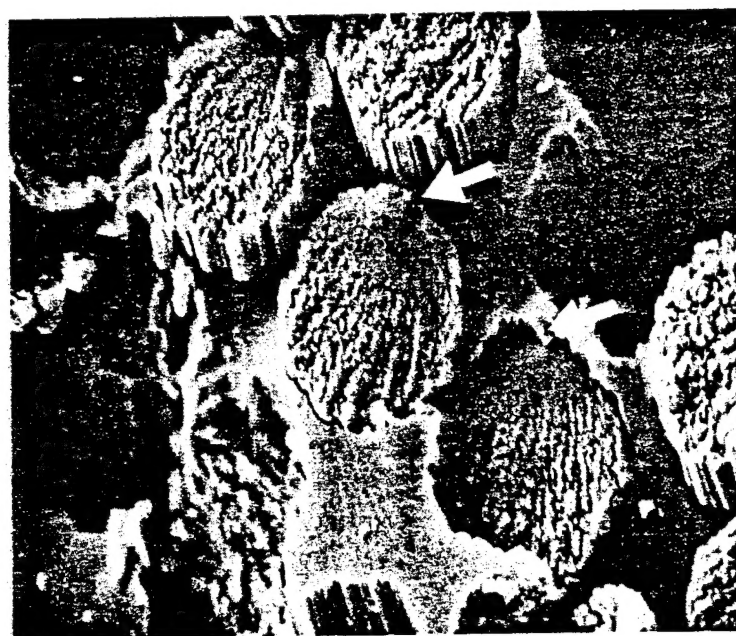
If a carbon fibre is not loaded by a uniform tensile stress, crack initiation may occur at the circumference of the fibre. This is what happened to several fibres shown in figure 22. On the resin fracture surface marks can be observed indicating the crack propagation direction.

Figure 22 Fracture initiation at the edge of a carbon fibre
(2300x)

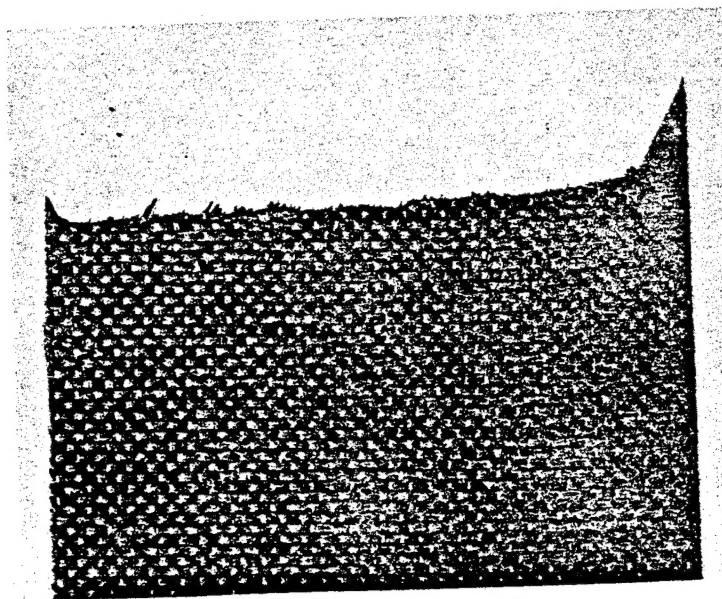
The photographs of cross plied carbon/epoxy fatigue specimens are shown in figures 23 and 24. The specimens have been tested at constant amplitude loading for $R > 0$. Fatigue failure initiation started by delamination at the edges of the specimens. Failure occurred after continued delamination.

Figure 23 Fracture surface of a carbon/epoxy specimen tested under fatigue loading

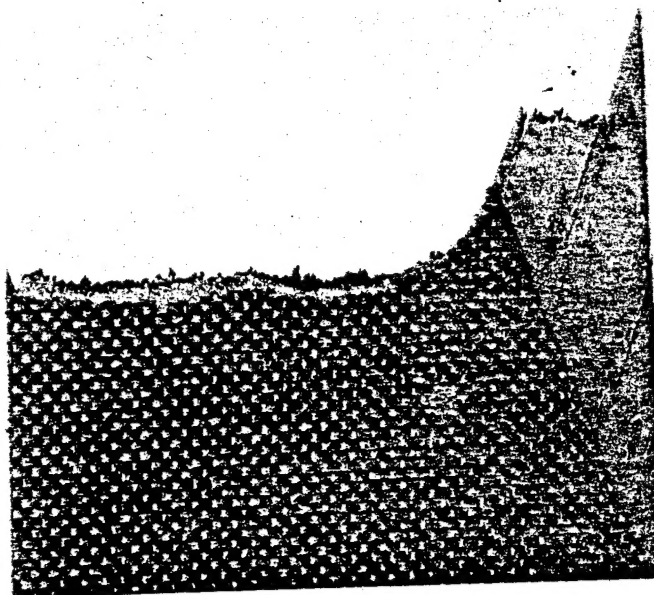
Figure 24 Fracture surface of a carbon/epoxy specimen tested under fatigue loading

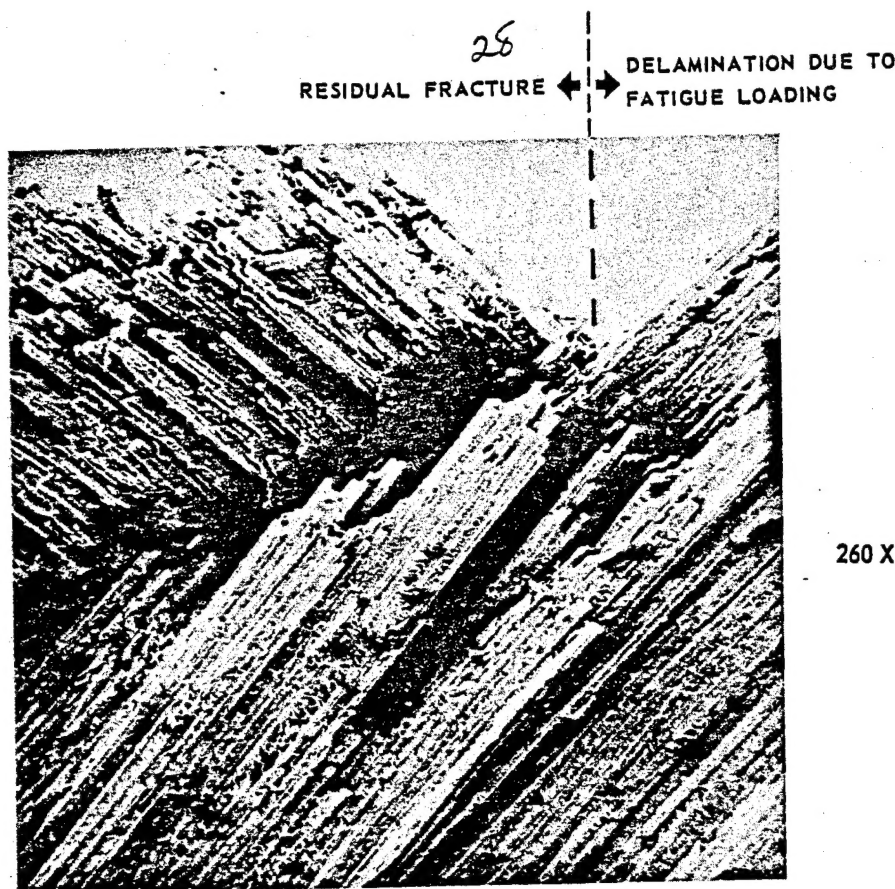
Figure 25 shows the transition of the zone with fatigue damage to that of residual fracture.

Figure 25 Transition of the zone with fatigue damage to that of residual fracture

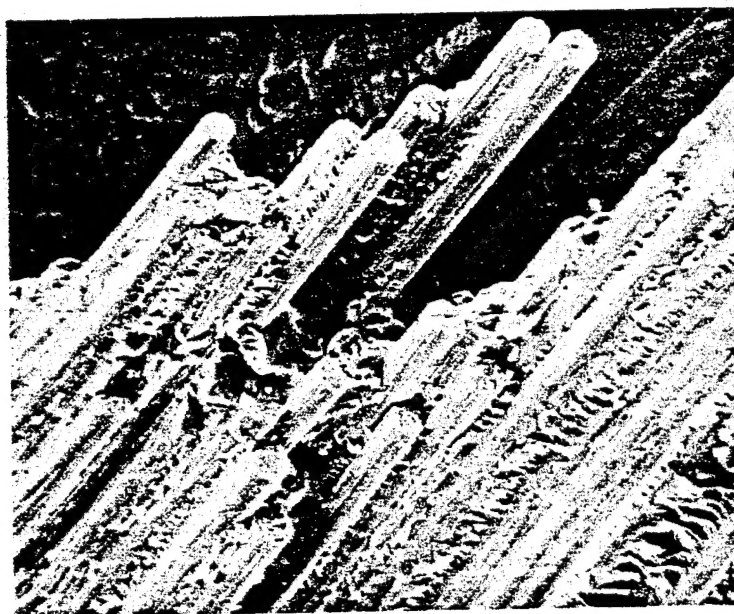
There was a strong interface, since at numerous locations on the overload part of the fracture surface integral units of broken fibres can be observed, figure 26.

Figure 26 SEM photograph showing a good interface bond in the cross plied laminate (650x)

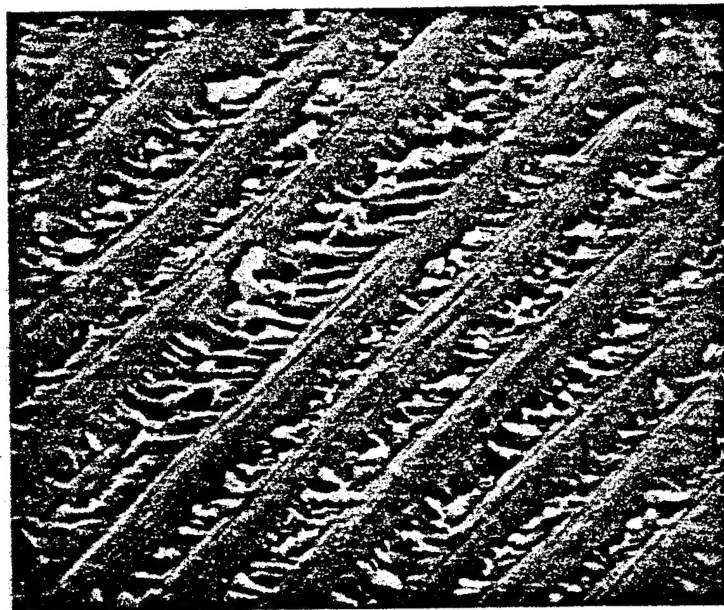
In figure 27, the fatigue failure, the surface is smooth and no resin particles adhere to the carbon fibres. During fatigue loading partial debonding of the fibre matrix interface probably occurred first, after which the matrix between the fibres failed by decohesion. The laminar shear fracture surface due to static loading, figure 28,

Figure 27 Shear failure by fatigue delamination (1240x)

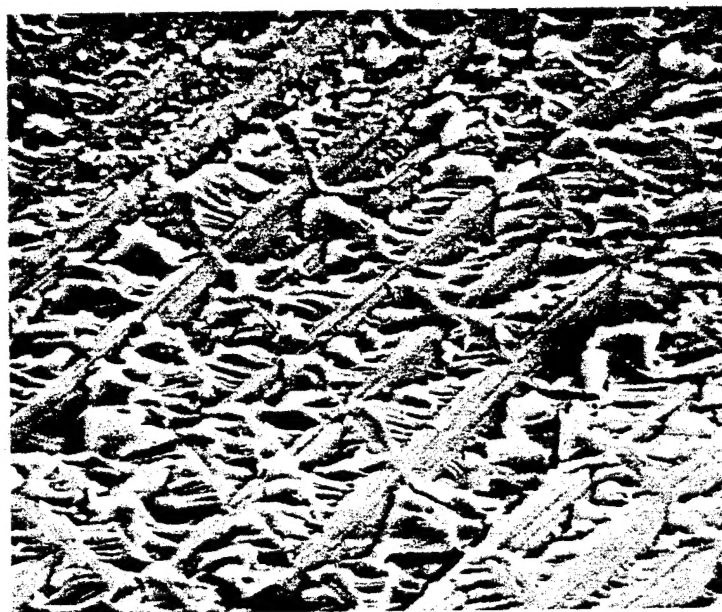
is rather rough and interface debonding is less evident. The difference in fracture surface appearance could be caused by the strain-rate dependency of the resin properties.

Figure 28 Shear failure in the residual fracture surface (1240x)
